Technical Report CHL-97-28
September 1997

Navigation Conditions at Lock and Dam 25, Mississippi River

Hydraulic Model Investigation

Final report

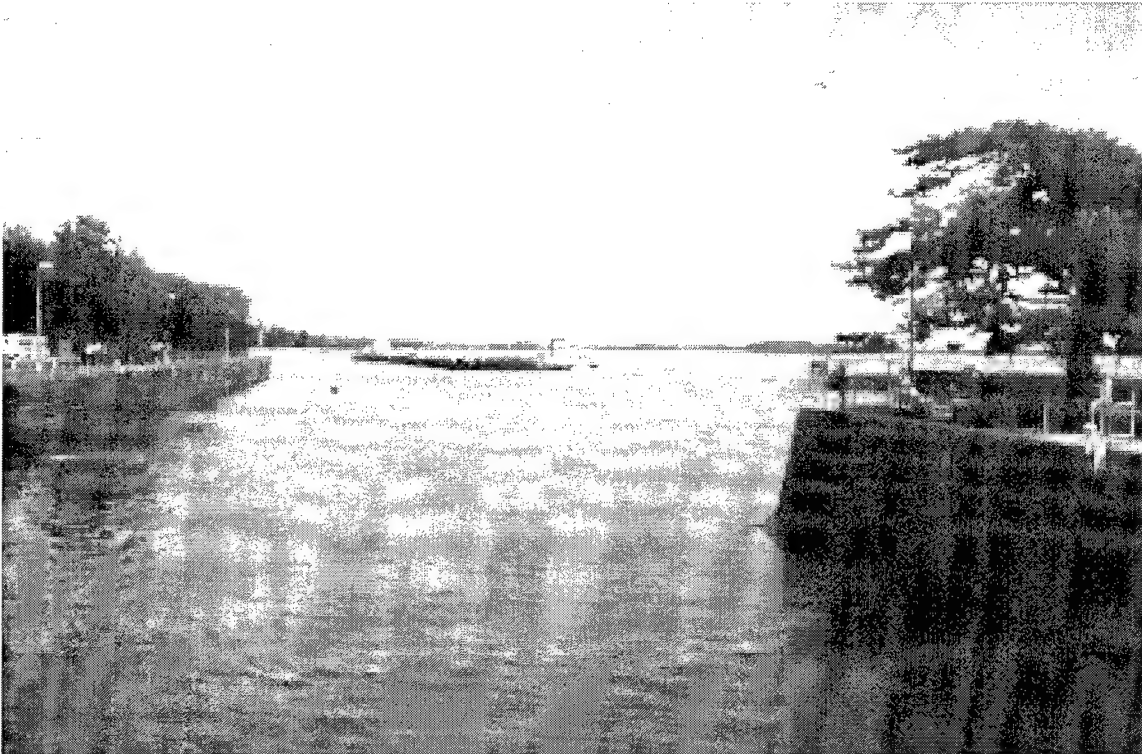
Photo 1. A helper towboat pushing a downbound tow into the right bank, looking upstream

A time-lapse video recorder and camera were installed at the project from December 1993 to October 1994 to record the path and maneuvering required for tows to enter and leave the upper lock approach (Photos 1-4). During this period, riverflows ranged from low to high and covered a range of outdraft conditions. This information was then compared to model data taken with model tows entering and leaving the upper lock approaches with various riverflows. This comparison indicated the model reproduced with a reasonable degree of accuracy prototype navigation conditions that exist at the project.

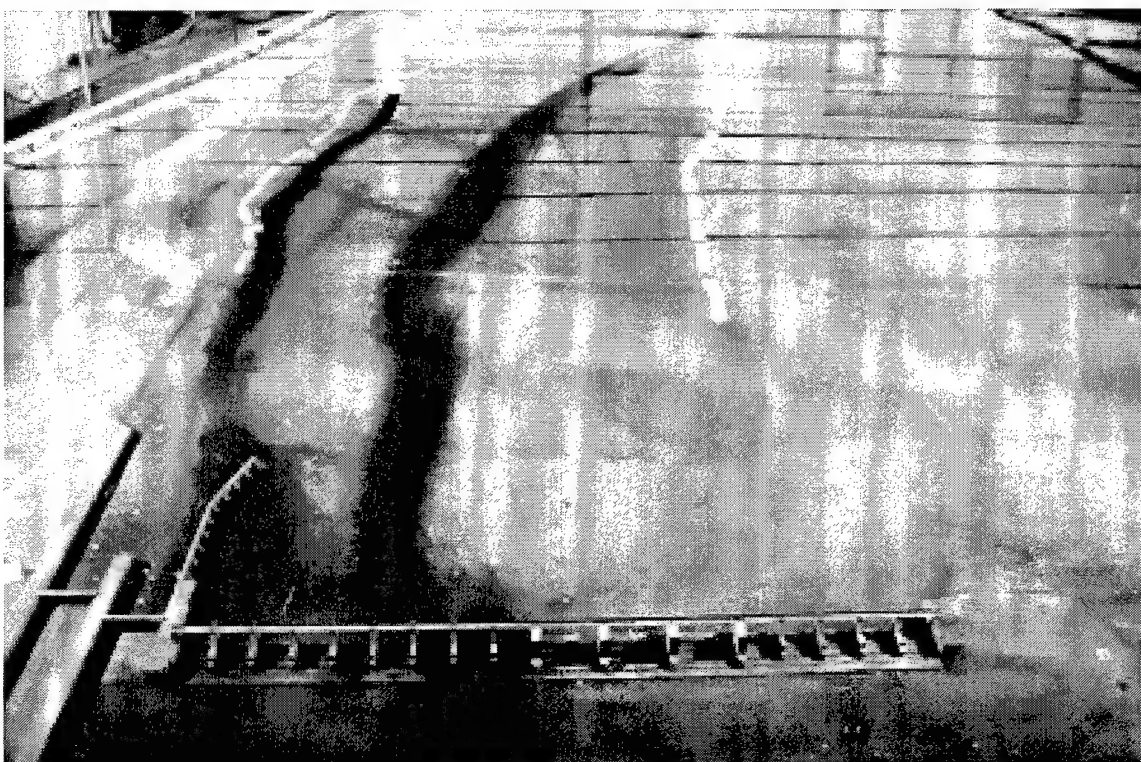
Photo 6. Existing conditions, looking upstream, discharge 166,000 cfs. Dye showing current pattern approaching existing lock

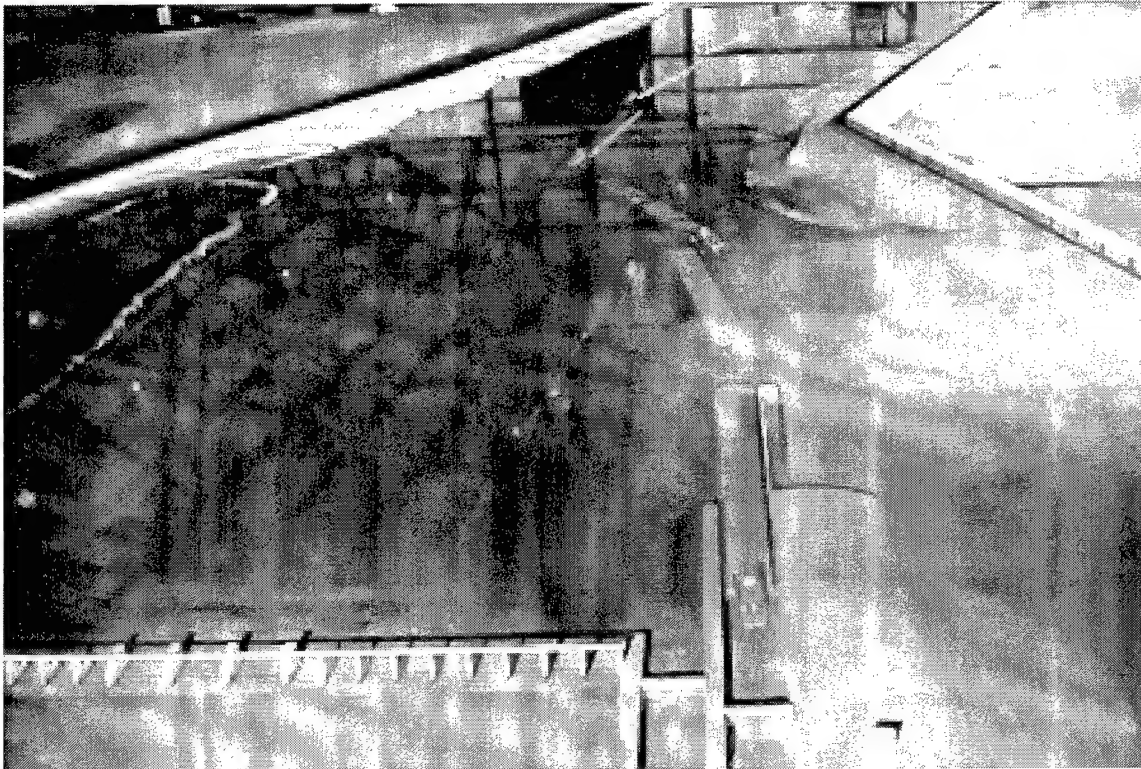
Photo 9. Existing conditions, looking downstream, discharge 166,000 cfs, path of downbound tow leaving existing lock

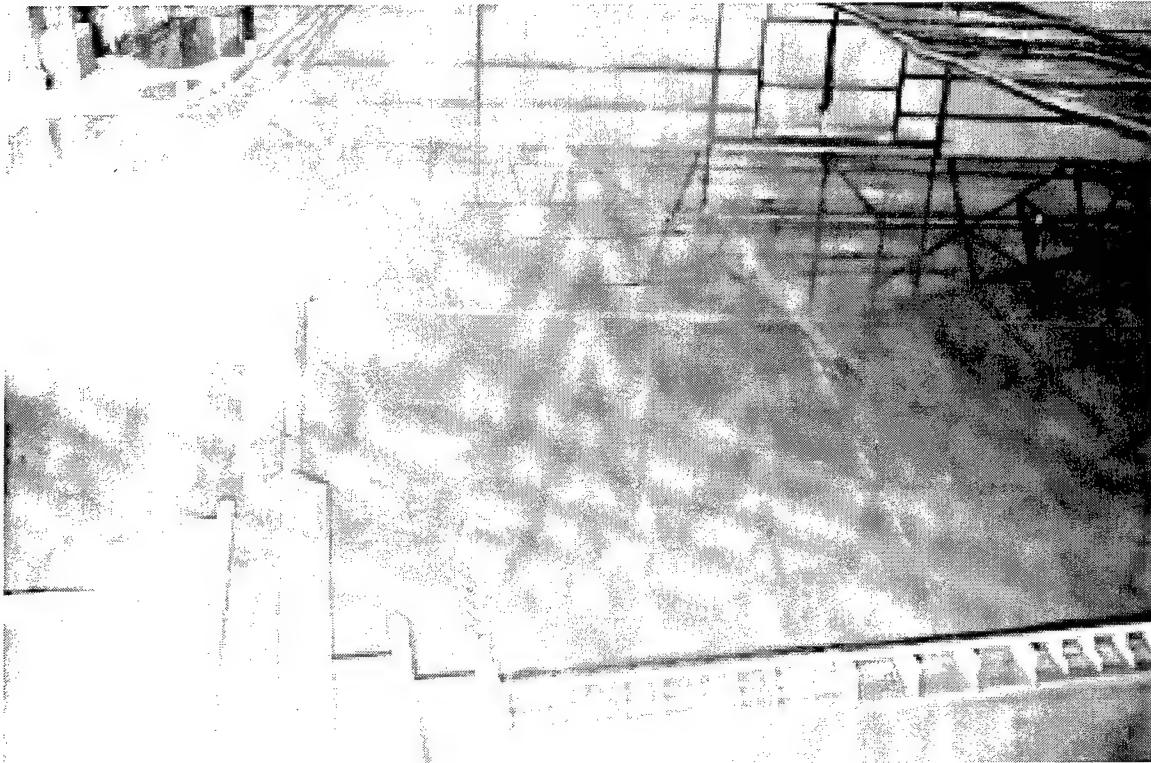
Photo 15. Lock Location 1, Plan A, looking upstream, discharge 138,000 cfs, path of upbound tow leaving 1,200-ft lock

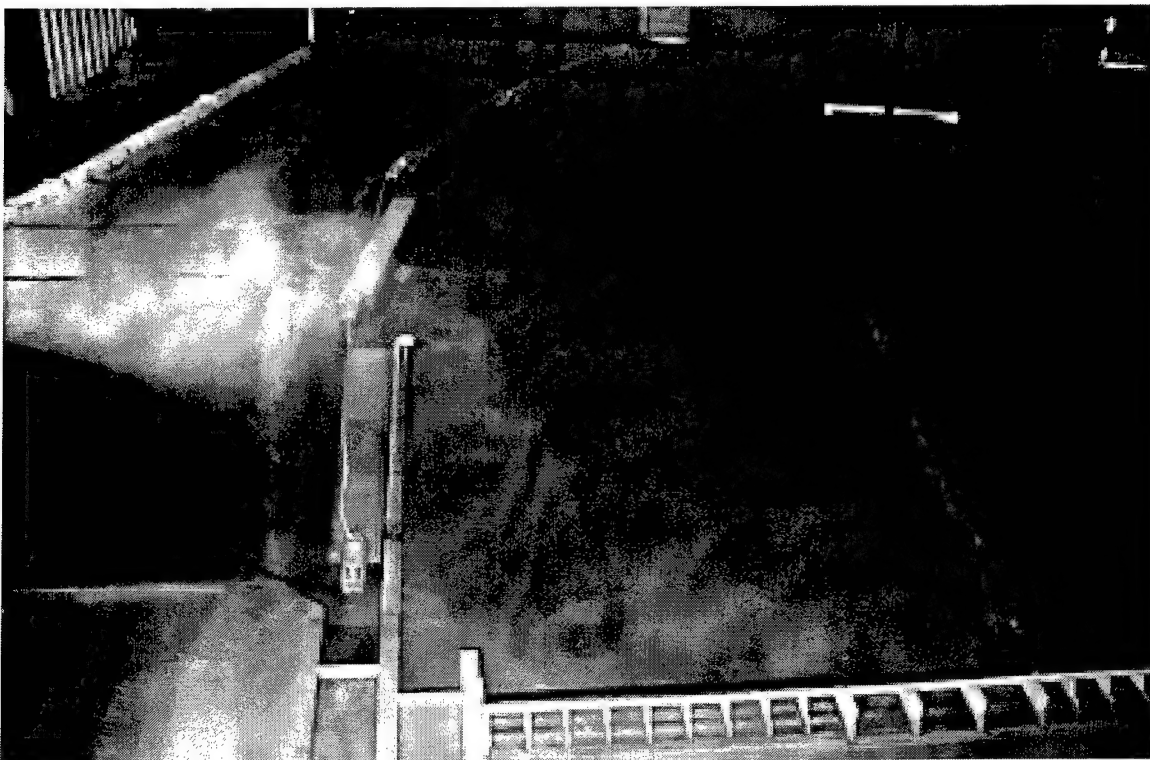
Photo 20. Lock Location 2, Plan A, looking upstream, discharge 327,000 cfs, path of upbound tow leaving 1,200-ft lock

crossing upstream of the lock, start reducing speed about one tow length upstream of the upper end of the guard wall, enter the lock approach at a slow speed, and align with the guard wall. As the tow entered the lock approach, the flow through the ports in the guard wall assisted the tow in aligning with and approaching the wall by moving the tow toward the wall. There was no indication of excessive flow through the ports. It should be noted that the short length of channel upstream of the lock provided marginally acceptable navigation conditions for downbound tows because the margin for pilot error or misaligned tows was small. A downbound tow was still turning to enter the upper approach less than one tow length upstream of the guard wall (Photo 19), and any error in alignment or judgment could have resulted in the tow either striking the end of the guard wall or being rotated around the upstream end of the guard wall. An upbound tow leaving the lock could move away from the guard wall, start turning riverward as the towboat cleared the upstream end of the guard wall, and navigate upstream through the reach without any major difficulties (Photo 20).
